**Flood Control Project Maintenance
Levee Inspections**

Maintenance Issue Types Only, Levee Inspection Report By Mile - Spring 2018

Reclamation District No. 0349 Sutter Island

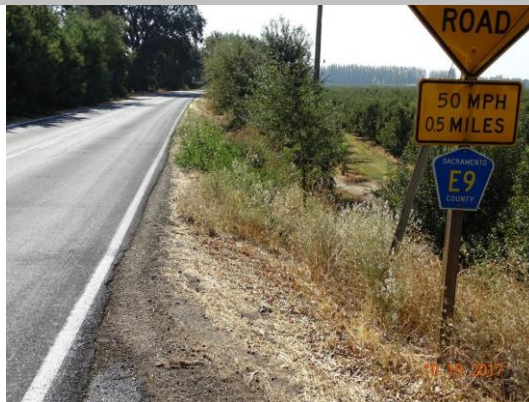
Photo 1 of 2 : SP_2018_RD0349_204_23_20180305_00010.jpg

LM Start	0.01	Rating **	U	Issue No.	23
LM End	0.68	Issue Type +	Ma	Location *	LS
Category	Earthen Levee			GPS Latitude/Longitude	
				Start	End
Item	Vegetation			38.327054 °	38.317598 °
				-121.577032 °	-121.579134 °
DWR ID	DWR_RD0349_01_f_2017_23				
Comment Code					
V1 : Control annual grass and weeds on the levee slopes and easements.					
Inspector Comment					
Landside vegetation should be cleared to allow inspection and access.

Landside vegetation should be cleared to allow inspection and access.

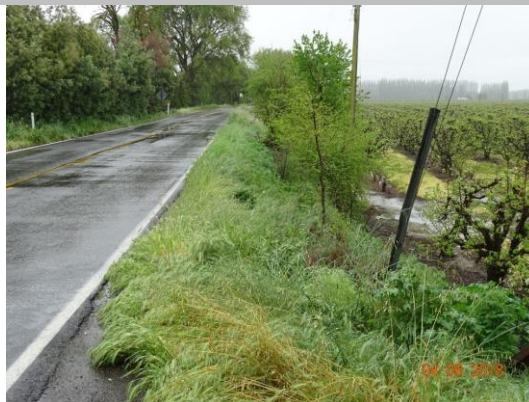
Photo 2 of 2 : SP_2018_RD0349_204_23_20180409_00034.jpg

Landside vegetation has not been managed.

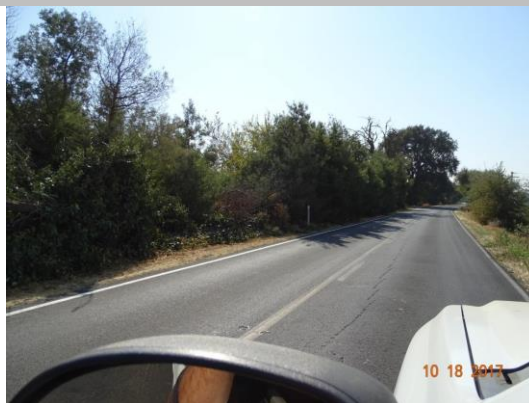
Photo 1 of 1 : SP_2018_RD0349_204_13_20180305_00003.jpg

Waterside vegetation should be cleared to 20 feet from crown for inspection and access.

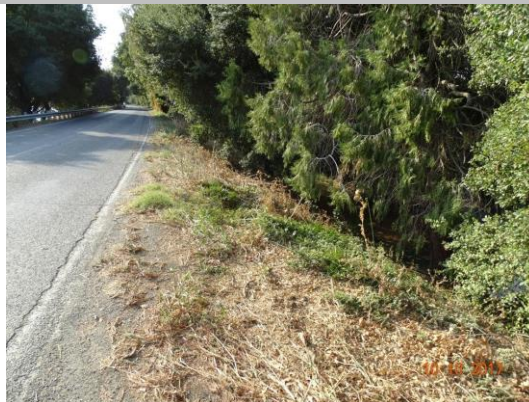
Photo 1 of 1 : SP_2018_RD0349_204_18_20180305_00007.jpg

Trim and thin trees on landside slope.

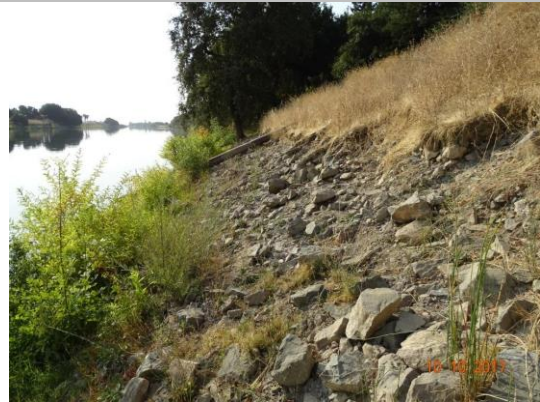
Photo 1 of 1 : SP_2018_RD0349_204_15_20180305_00004.jpg

LM Start	1.00	Rating **	M	Issue No.	15
LM End	1.06	Issue Type +	Ma	Location *	
Category	Supplemental			GPS Latitude/Longitude	
				Start	End
Item	2017 Storm Damage			38.312911 °	38.312131 °
				-121.578528 °	-121.578292 °
DWR ID	DWR_RD0349_01_f_2017_15

Comment Code					
Inspector Comment					
Levee Evaluation Comments					
Description:District Station 52+92 to 55+88, Sec. 06, T. 5 N. R. 4 E., M.D.M. Approximately 296 linear-feet of eroded area exists along the waterside levee slope of the Sacramento River (Unit 1). Erosion commences at approximately 3/4 of the way down the slope from the crown and extends into the rip rap. Some rip rap has been pulled off in this section.					
Site ID No:318					
Site Designation:LMA-145					
Repair Type: Erosion					
Rating:Area of Concern					
Field Date:7/28/2017					
Notes: slope too steep, vegetation too thick for clear inspection, no direct visual of damage

Waterside erosion at LM 1.02.

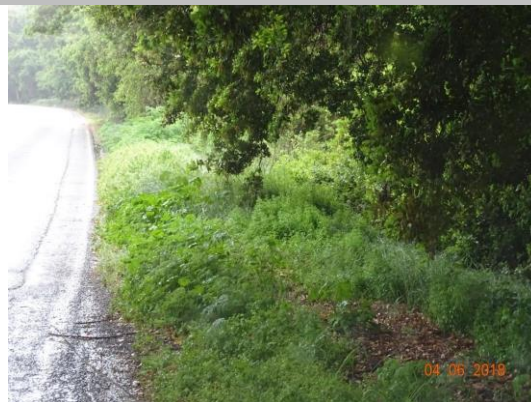
Photo 1 of 1 : SP_2018_RD0349_204_29_20180409_00036.jpg

Manage landside vegetation to allow inspection and access.

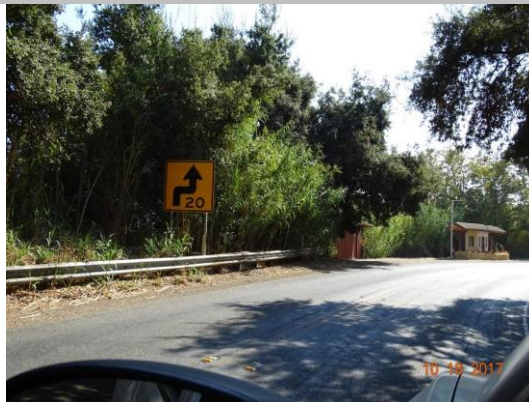
Photo 1 of 1 : SP_2018_RD0349_204_34_20180305_00015.jpg

Arundo completely blocks visibility and access to waterside of levee.
Must be removed.

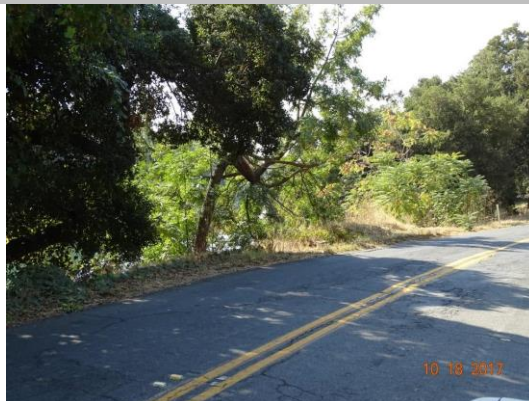
Photo 1 of 1 : SP_2018_RD0349_205_44_20180305_00041.jpg

Waterside vegetation should be removed or thinned to 20 feet from crown to allow inspection and access.

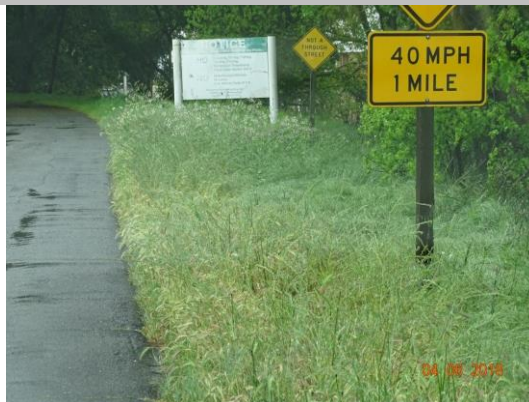
Photo 1 of 1 : SP_2018_RD0349_205_45_20180409_00112.jpg

LM Start	0.04	Rating **	U	Issue No.	45
LM End	0.08	Issue Type +	Ma	Location *	LS
Category	Earthen Levee			GPS Latitude/Longitude	
				Start	End
Item	Vegetation			38.304886 °	38.304726 °
				-121.575406 °	-121.576085 °
DWR ID	DWR_RD0349_02_s_2018_45				
Comment Code					
V1 : Control annual grass and weeds on the levee slopes and easements.					
Inspector Comment

Manage landside vegetation to allow inspection and access.

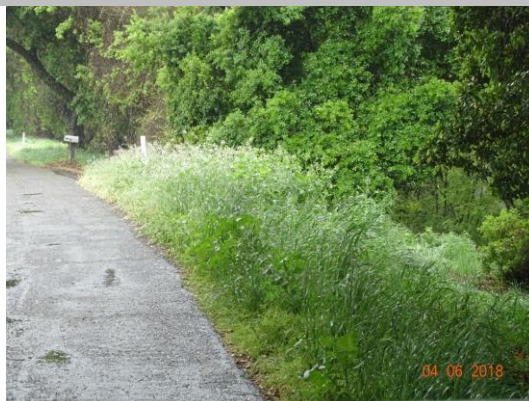
Photo 1 of 1 : SP_2018_RD0349_205_71_20180409_00114.jpg

Manage landside vegetation to allow inspection and access.

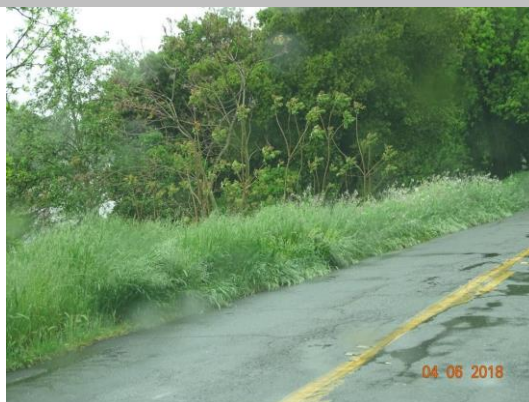
Photo 1 of 1 : SP_2018_RD0349_205_72_20180409_00115.jpg

LM Start	0.12	Rating **	U	Issue No.	72	
LM End	0.17	Issue Type +	Ma	Location *	WS	
Category	Earthen Levee			GPS Latitude/Longitude		
				Start		End
Item	Vegetation			38.304405 °		38.303999 °
				-121.576763 °		-121.577367 °
DWR ID	DWR_RD0349_02_s_2018_72					
Comment Code						
V1 : Control annual grass and weeds on the levee slopes and easements.						
Inspector Comment

Reduce waterside vegetation to 20' from crown.

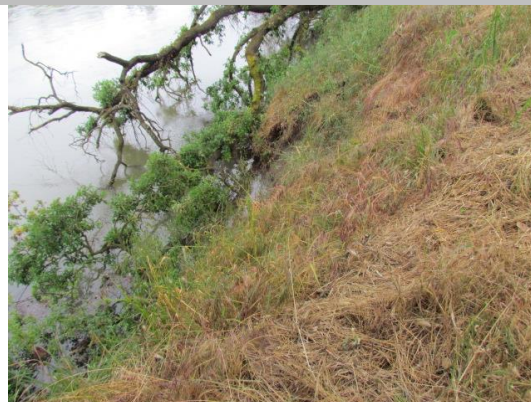
Photo 1 of 1 : SP_2018_RD0349_205_39_20180305_00029.jpg

LM Start	0.35	Rating **	A/W	Issue No.	39
LM End	0.35	Issue Type +	Ma	Location *	WS
Category	Earthen Levee			GPS Latitude/Longitude	
				Start	End
Item	Slope Stability			38.302368 °	38.302368 °
				-121.579933 °	-121.579933 °
DWR ID	DWR_RD0349_02_s_2017_39				
Comment Code					
S1 : Repair slope instability.					
Inspector Comment					
This erosion occurred during the Feb Storm 2017 event.

RD 349 Unit 2 levee mile 0.35 waterside slope and shoulder.

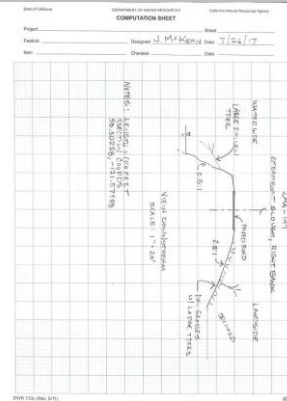
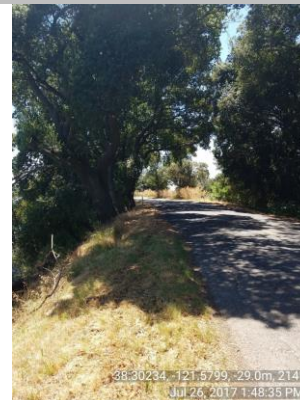
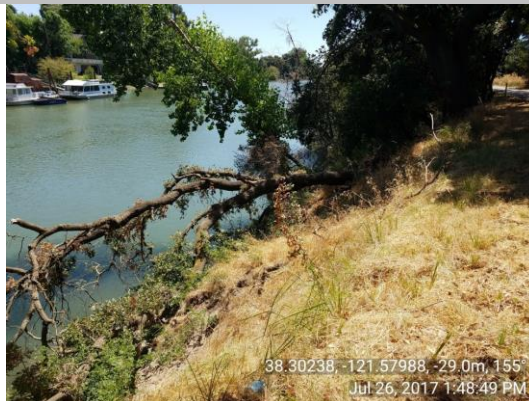
LM Start	0.35	Rating **	A/W	Issue No.	32
LM End	0.37	Issue Type +	Ma	Location *	
Category	Supplemental		GPS Latitude/Longitude		
			Start	End	
Item	2017 Storm Damage		38.302217°	38.302017°	
			-121.579847°	-121.580017°	
DWR ID	DWR_RD0349_02_f_2017_32				
Comment Code					
Inspector Comment					
<p>Levee Evaluation Comments</p> <p>Description: District Station 19+13 to 20+07, Sec. 07, T. 5 N. R. 4 E., M.D.M. . Approximately 94 linear feet of erosion exists on the water side slope of the Steamboat Slough levee (Unit 2). The erosion area commences approximately halfway down the slope from the levee crown and extends to the waterside toe. No rip rap is visible in this area.</p> <p>Site ID No: 320</p> <p>Site Designation: LMA-147</p> <p>Repair Type: Erosion</p> <p>Rating: Critical</p> <p>Field Date: 7/26/2017</p> <p>Notes: fallen tree present</p>

LM Start	0.35	Rating **	A/W	Issue No.	32 (cont)
LM End	0.37	Issue Type +	Ma	Location *	
Category	Supplemental			GPS Latitude/Longitude	
				Start	End
Item	2017 Storm Damage			38.302217 °	38.302017 °
				-121.579847 °	-121.580017 °
DWR ID	DWR_RD0349_02_f_2017_32				
Comment Code					
Inspector Comment					
Levee Evaluation Comments					
Description: District Station 19+13 to 20+07, Sec. 07, T. 5 N. R. 4 E., M.D.M. . Approximately 94 linear feet of erosion exists on the water side slope of the Steamboat Slough levee (Unit 2). The erosion area commences approximately halfway down the slope from the levee crown and extends to the waterside toe. No rip rap is visible in this area.					
Site ID No:320					
Site Designation:LMA-147					
Repair Type: Erosion					
Rating:Critical					
Field Date:7/26/2017					
Notes: fallen tree present

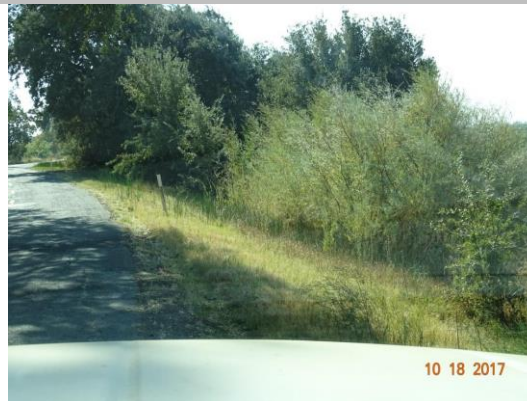
Photo 1 of 1 : SP_2018_RD0349_205_52_20180305_00046.jpg

Landside trees should be trimmed and maintained to allow inspection and access to levee slope and toe.

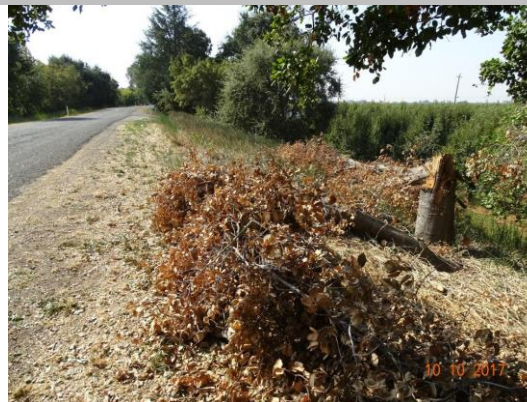
Photo 1 of 1 : SP_2018_RD0349_205_7_20180305_00008.jpg

LM Start	0.93	Rating **	M	Issue No.	7
LM End	0.93	Issue Type +	Ma	Location *	LS
Category	Earthen Levee			GPS Latitude/Longitude	
				Start	End
Item	Encroachments			38.294385 °	38.294385 °
				-121.583351 °	-121.583351 °
DWR ID	DWR_RD0349_02_f_2017_7				
Comment Code					
TR : Tree or limb					
Inspector Comment					
Fallen tree has been removed from road, but currently obstructs visibility and access to landside slope. Smaller branches/foliage are stacked along both roadway shoulders. All debris should be removed from levee.

Fallen tree on landside slope.

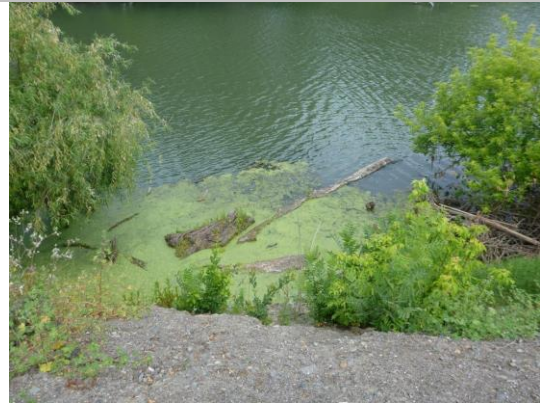
Photo 3 of 3 : SP_2018_RD0349_205_40_20180305_00032.jpg

LM Start	1.33	Rating **	M	Issue No.	40 (cont)	
LM End	1.49	Issue Type +	Ma	Location *		
Category	Supplemental			GPS Latitude/Longitude		
				Start	End	
Item	2017 Storm Damage			38.288727 °	38.286475 °	
				-121.583823 °	-121.585026 °	
DWR ID	DWR_RD0349_02_f_2017_40					
Comment Code						
Inspector Comment						
Levee Evaluation Comments						
Description:						
Site ID No:66						
Site Designation:DWR_RD0349_02_s_2012_28						
Repair Type: Erosion						
Rating:Area of Concern						
Field Date:6/7/2017						
Notes: dense vegetation and large trees hindered visibility; slope riprap appeared failing in some parts

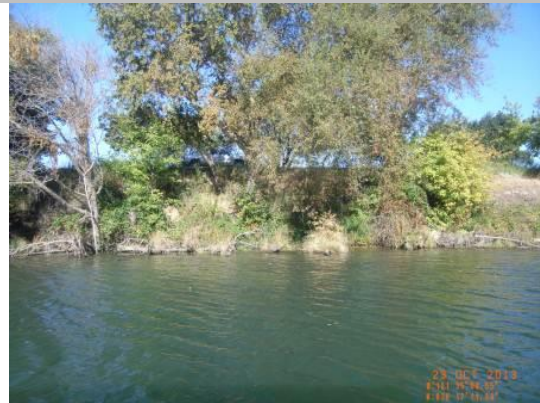
Photo 1 of 1 : SP_2018_RD0349_205_10_20180305_00010.jpg

LM Start	1.33	Rating **	A/W	Issue No.	10
LM End	1.49	Issue Type +	Ma	Location *	WS
Category	Supplemental			GPS Latitude/Longitude	
				Start	End
Item	2015 USACE Erosion Survey, DRAFT			38.288727 °	38.286475 °
				-121.583823 °	-121.585026 °
DWR ID	DWR_RD0349_02_s_2016_10

Comment Code					
Inspector Comment					
1997 - Erosion of very sandy levee behind large stand of riparian vegetation on top right bank. Dry ravel of sand. 1999 - Quarry waste rock was dumped down the levee slope; poor repair job; still eroding in places. Eroding at midslope off fabric. 2005 - Length revised, only the middle 150 - 200 ft are eroding. 2006 - Some rock/small material dumped down the bank but it is slowly unraveling. Upstream end is unraveling faster. Steep slope with poor gradation so fines are washing out. 2010 - Lots of overhanging trees and erosion pockets. 2011 - This site is upgraded to CRITICAL. Near vertical bank at the downstream end. New erosion at various locations throughout the site. 2015: No observed changes. [2015 Site ID: STM_24-7_R]

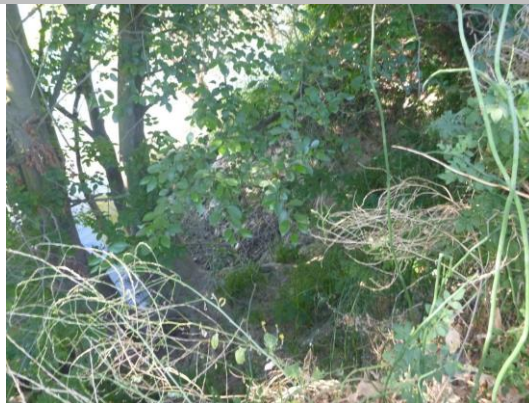
Photo 2 of 2 : SP_2018_RD0349_205_37_20180305_00028.jpg

LM Start	1.48	Rating **	A/W	Issue No.	37 (cont)
LM End	1.49	Issue Type +	Ma	Location *	
Category	Supplemental			GPS Latitude/Longitude	
				Start	End
Item	2017 Storm Damage			38.286708 °	38.286569 °
				-121.584839 °	-121.585042 °
DWR ID	DWR_RD0349_02_f_2017_37				
Comment Code					
Inspector Comment					
Levee Evaluation Comments					
Description:District Station 78+51 to 79+28, Sec. 18, T. 5 N. R. 4 E., M.D.M. Approximately 77 linear feet of erosion and scour exist along the water side slope of Steamboat Slough (Unit 2). The erosion area commences approximately halfway down the slope from the levee crown and extends to the waterside toe around existing trees. No rip rap is visible in this area.					
Site ID No:323					
Site Designation:LMA-150					
Repair Type: Erosion					
Rating:Area of Concern					
Field Date:7/28/2017					
Notes: no berm

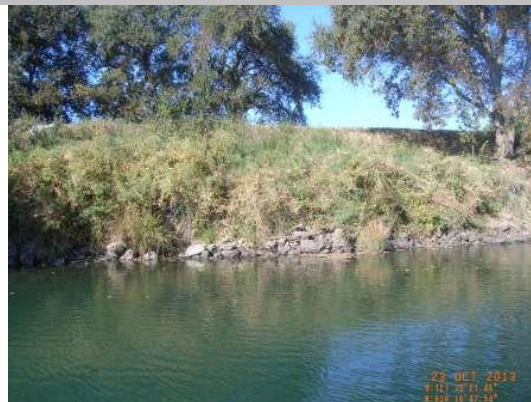
Photo 1 of 1 : SP_2018_RD0349_205_19_20180305_00014.jpg

LM Start	2.04	Rating **	M	Issue No.	19
LM End	2.05	Issue Type +	Ma	Location *	WS
Category	Supplemental			GPS Latitude/Longitude	
				Start	End
Item	2015 USACE Erosion Survey, DRAFT			38.280069 °	38.279919 °
				-121.589443 °	-121.589438 °
DWR ID	DWR_RD0349_02_s_2016_19				
Comment Code					
Inspector Comment					
2011 - Small scallop caused by erosion and wave wash. 2015: No observed changes. [2015 Site ID: STM_24-1_R]

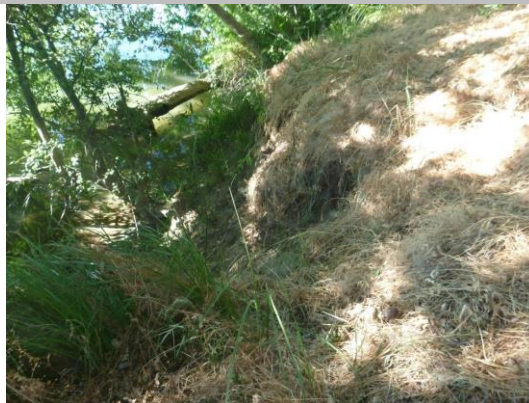
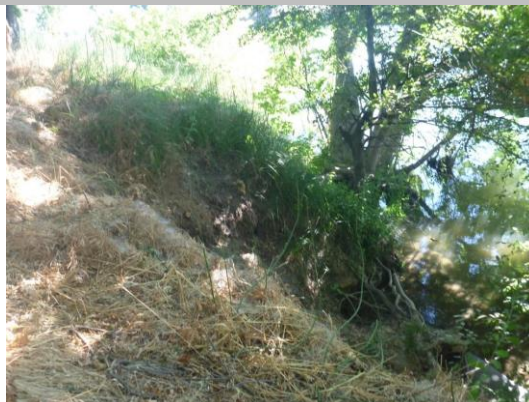
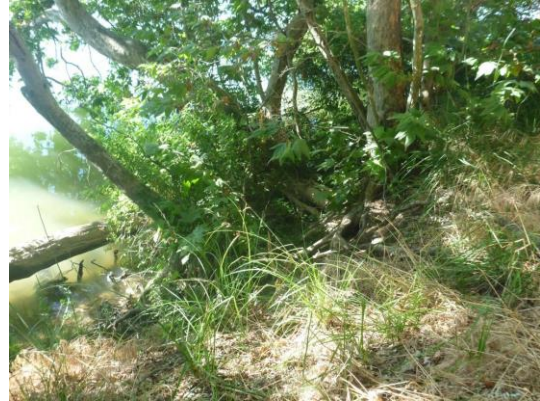
LM Start	2.11	Rating **	A/W	Issue No.	41
LM End	2.13	Issue Type +	Ma	Location *	
Category	Supplemental			GPS Latitude/Longitude	
				Start	End
Item	2017 Storm Damage			38.279039 °	38.278806 °
				-121.589664 °	-121.589783 °
DWR ID	DWR_RD0349_02_f _ 2017_41				
Comment Code					
Inspector Comment					
Levee Evaluation Comments					
Description:District Station 112+11 to 113+04, Sec. 13, T. 5 N. R. 3 E., M.D.M. Approximately 93 linear feet of erosion exists along the water side slope of Steamboat Slough (Unit 2). The erosion area commences approximately 3/4 of the way down the slope from the levee crown and extends to the waterside toe around existing trees. No rip rap is visible in this area.					
Site ID No:324					
Site Designation:LMA-151					
Repair Type: Erosion					
Rating:Serious					
Field Date:7/28/2017					
Notes: no berm

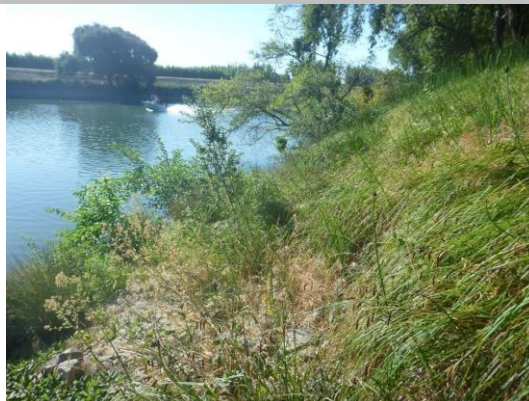
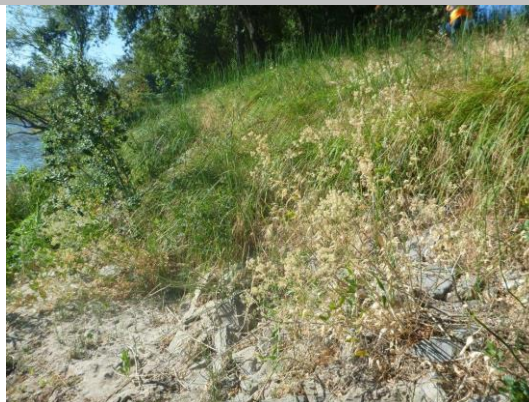
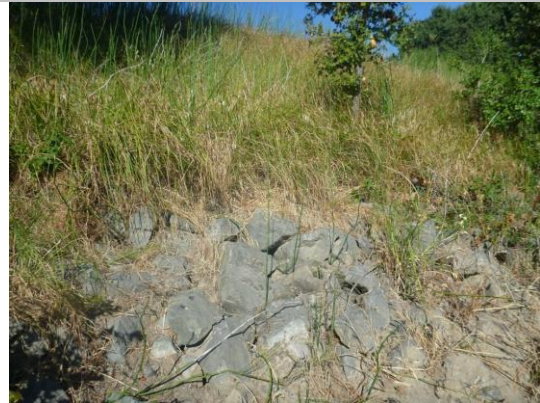
LM Start	2.56	Rating **	A/W	Issue No.	43
LM End	2.59	Issue Type +	Ma	Location *	
Category	Supplemental			GPS Latitude/Longitude	
				Start	End
Item	2017 Storm Damage			38.273769 °	38.273386 °
				-121.588742 °	-121.588672 °
DWR ID	DWR_RD0349_02_f_2017_43				
Comment Code					
Inspector Comment					
Levee Evaluation Comments					
Description:District Station 135+81 to 137+00, Sec. 13, T. 5 N. R. 3 E., M.D.M. Approximately 119 linear feet of sloughing exists due to scour along the water side toe of Steamboat Slough (Unit 2). The erosion area commences approximately 3/4 of the way down the slope from the levee crown and extends to the waterside toe. No rip rap is visible in this area.					
Site ID No:326					
Site Designation:LMA-153					
Repair Type: Erosion					
Rating:Area of Concern					
Field Date:7/28/2017					
Notes: no berm

LM Start	2.56	Rating **	A/W	Issue No.	43 (cont)
LM End	2.59	Issue Type +	Ma	Location *	
Category	Supplemental			GPS Latitude/Longitude	
				Start	End
Item	2017 Storm Damage			38.273769 °	38.273386 °
				-121.588742 °	-121.588672 °
DWR ID	DWR_RD0349_02_f_2017_43				
Comment Code					
Inspector Comment					
Levee Evaluation Comments					
Description:District Station 135+81 to 137+00, Sec. 13, T. 5 N. R. 3 E., M.D.M. Approximately 119 linear feet of sloughing exists due to scour along the water side toe of Steamboat Slough (Unit 2). The erosion area commences approximately 3/4 of the way down the slope from the levee crown and extends to the waterside toe. No rip rap is visible in this area.					
Site ID No:326					
Site Designation:LMA-153					
Repair Type: Erosion					
Rating:Area of Concern					
Field Date:7/28/2017					
Notes: no berm

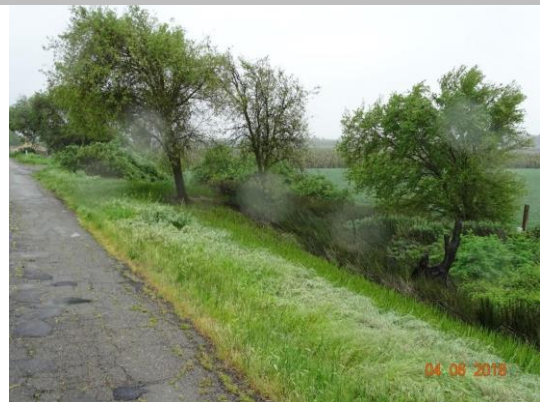
Photo 1 of 1 : SP_2018_RD0349_205_61_20180409_00117.jpg

LM Start	2.87	Rating **	U	Issue No.	61
LM End	2.92	Issue Type +	Ma	Location *	LS
Category	Earthen Levee			GPS Latitude/Longitude	
				Start	End
Item	Vegetation			38.269471 °	38.268743 °
				-121.589826 °	-121.589480 °
DWR ID	DWR_RD0349_02_f_2017_61				
Comment Code					
V2 : Remove the wild growth other than native grasses from the levee slopes.					
Inspector Comment					
Thick brush, vines, horsetail and grass block visibility and access. Should be cleared.

Manage landside vegetation to allow inspection and access.

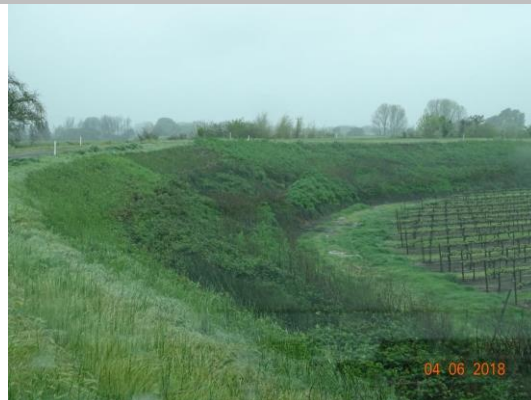
Photo 1 of 1 : SP_2018_RD0349_205_62_20180409_00119.jpg

Remove berry vines to allow inspection and access.

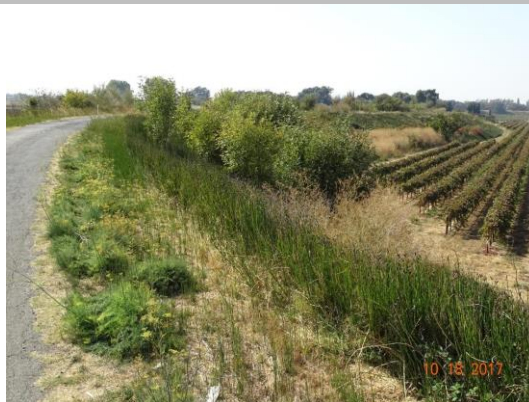
Photo 1 of 1 : SP_2018_RD0349_205_63_20180305_00053.jpg

Landside trees should be trimmed or thinned to allow inspection and access to levee slope and toe.

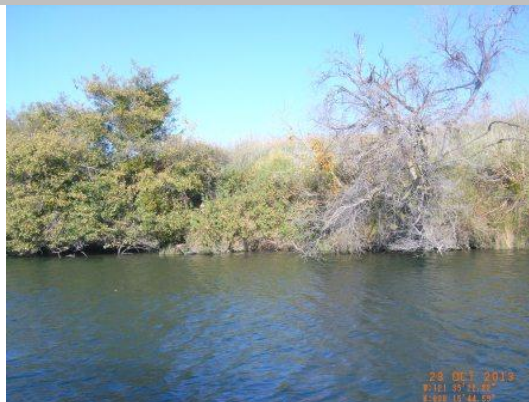
Photo 1 of 1 : SP_2018_RD0349_205_11_20180305_00011.jpg

LM Start	3.38	Rating **	M	Issue No.	11
LM End	3.49	Issue Type +	Ma	Location *	WS
Category	Supplemental			GPS Latitude/Longitude	
				Start	End
Item	2015 USACE Erosion Survey, DRAFT			38.262510 °	38.262533 °
				-121.589481 °	-121.591690 °
DWR ID	DWR_RD0349_02_s_2016_11				
Comment Code					
Inspector Comment					
2010 - Slumping sections on the lower bank, appears to be scouring around the trees. 2011 - Soil beach at toe. 2015: No observed changes. [2015 Site ID: STM_22-8_R]

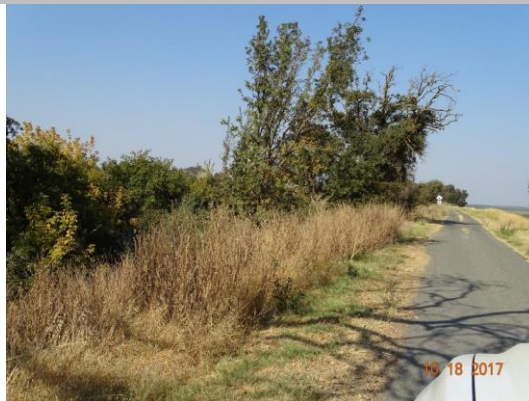
Photo 1 of 1 : SP_2018_RD0349_206_34_20180305_00005.jpg

Waterside vegetation should be removed to 20 feet from crown to allow inspection and access.

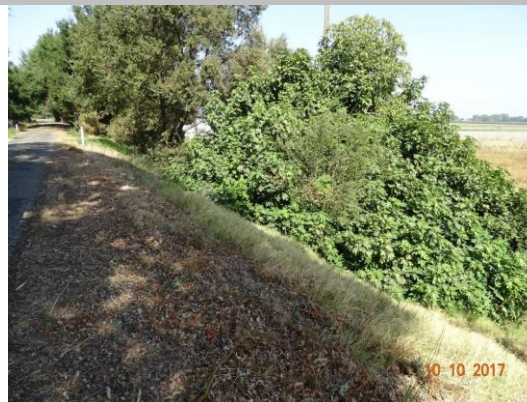
Photo 1 of 1 : SP_2018_RD0349_206_8_20180305_00001.jpg

Trim trees on landside at LM 0.76.

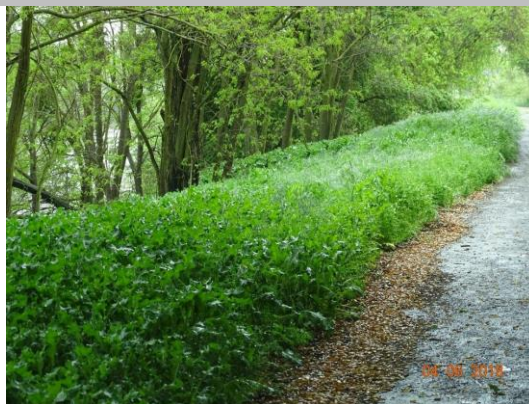
Photo 1 of 1 : SP_2018_RD0349_206_68_20180409_00089.jpg

Waterside vegetation should be reduced to 20' from crown.

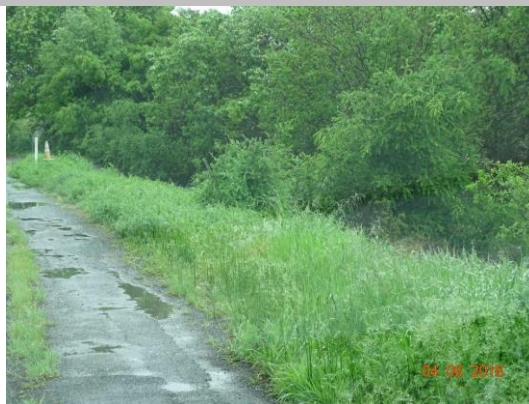
Photo 1 of 1 : SP_2018_RD0349_206_69_20180409_00090.jpg

Manage landside vegetation to allow inspection and access.

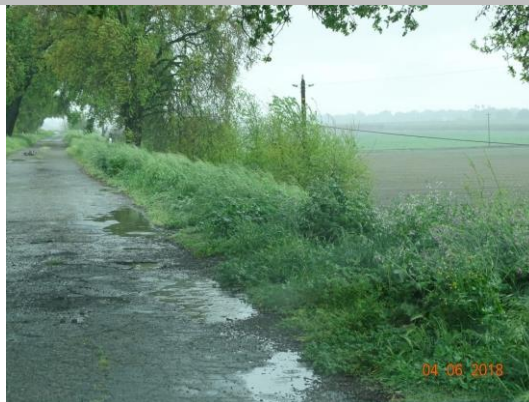
Photo 1 of 1 : SP_2018_RD0349_206_71_20180409_00092.jpg

Manage landside vegetation to allow inspection and access.

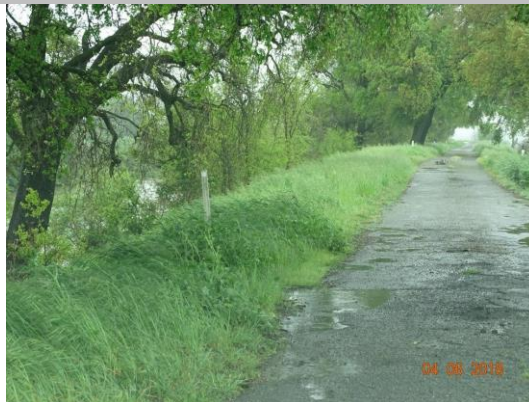
Photo 1 of 1 : SP_2018_RD0349_206_70_20180409_00091.jpg

Waterside vegetation should be reduced to 20' from crown.

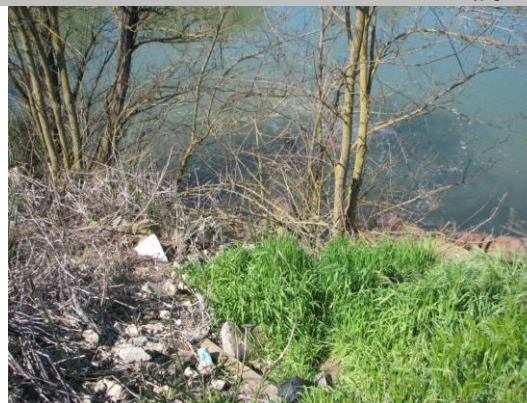
Photo 2 of 2 : UCIP_SP_2018_43446_36726.jpg

View of all 3 pipes through levee and visible on waterward toe.

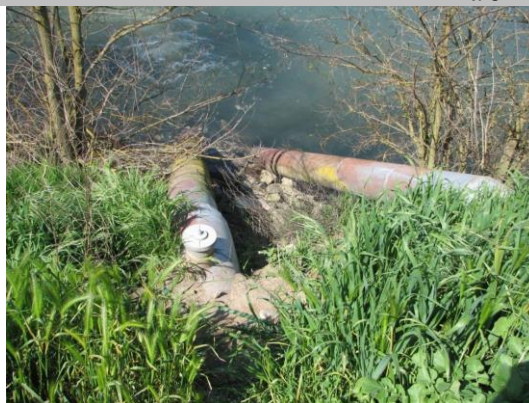
Photo 2 of 3 : UCIP_SP_2018_43445_36727.jpg

View of pipe on waterward side--pipe running. Siphon breaker visible on pipe.

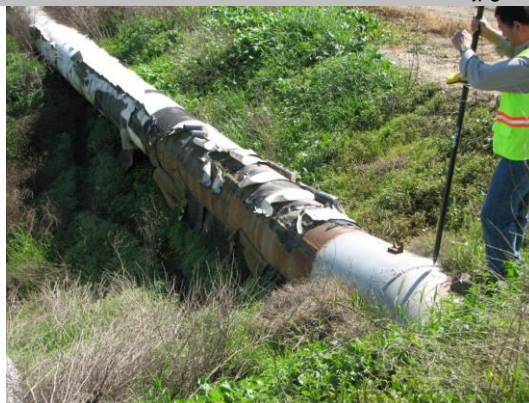
Photo 3 of 3 : UCIP_SP_2018_43445_36728.jpg

Pipe is wrapped--unwrapped coating.

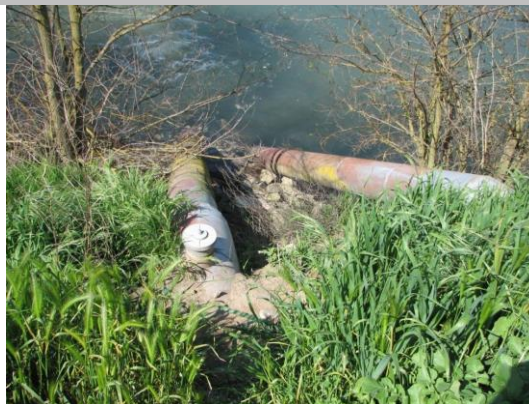
Photo 2 of 3 : UCIP_SP_2018_21632_36731.jpg

View of waterward side--2-24 inch pipes.

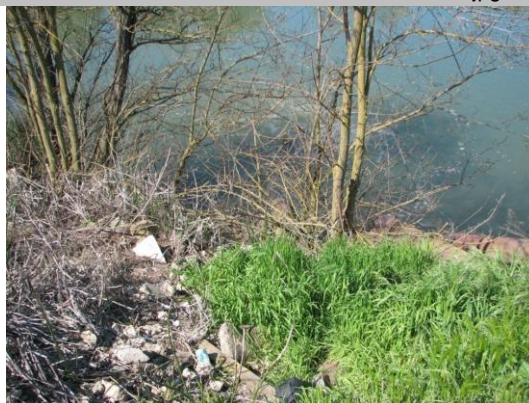
Photo 3 of 3 : UCIP_SP_2018_21632_36734.jpg

All 3 pipes visible on waterward side--tall grass limits inspection on waterward side.

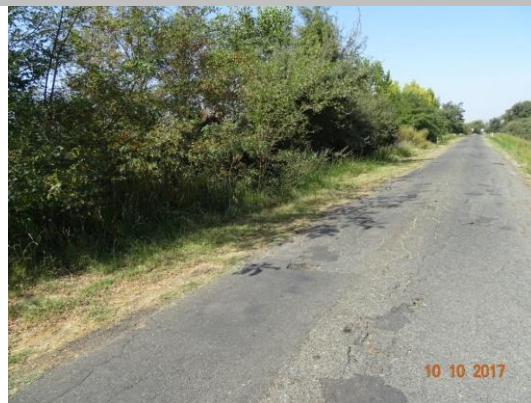
Photo 1 of 1 : SP_2018_RD0349_206_41_20180305_00010.jpg

Trim trees at LM 2.84.

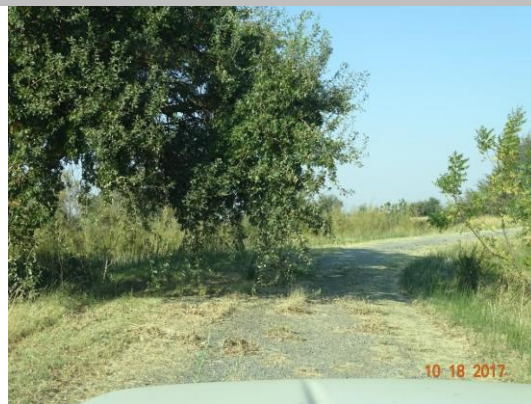
Photo 1 of 1 : SP_2018_RD0349_206_46_20180305_00011.jpg

Trim trees to 12 feet above crown road.

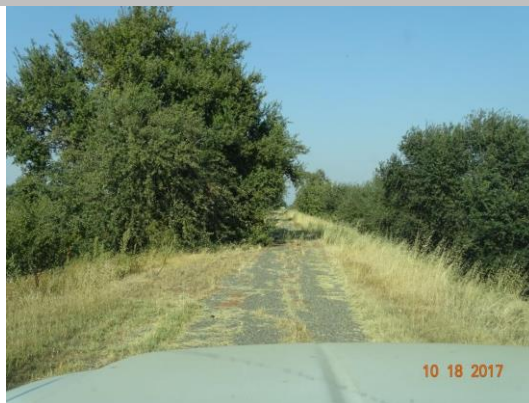
Photo 1 of 1 : SP_2018_RD0349_206_53_20180305_00015.jpg

Trim trees to 12 feet above crown road.

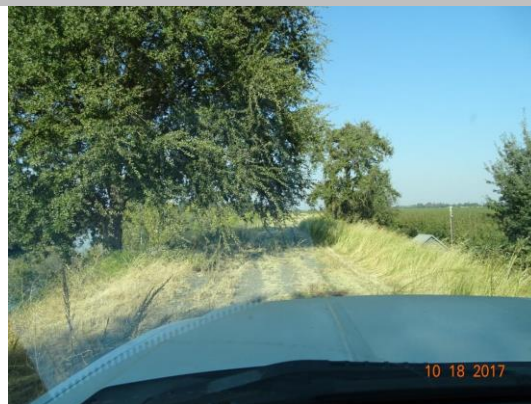
Photo 1 of 1 : SP_2018_RD0349_206_56_20180305_00017.jpg

Trim trees to 12 feet above levee crown.

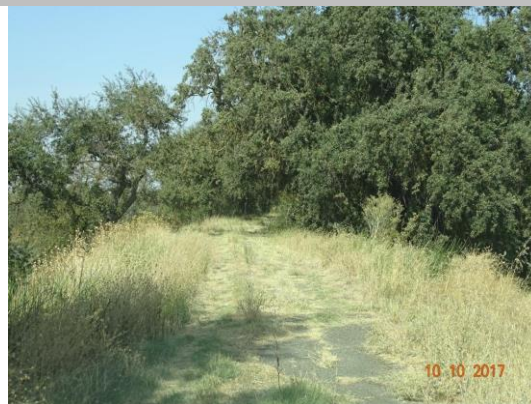
Photo 1 of 1 : SP_2018_RD0349_206_47_20180305_00012.jpg

Crown vegetation at LM 4.92.

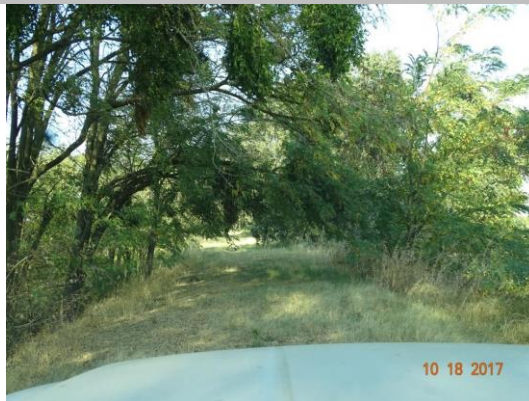
Photo 1 of 1 : SP_2018_RD0349_206_60_20180305_00018.jpg

Trim trees to 12 feet above levee crown.
